# Present status of RIKEN power coupler

OZEKI, Kazutaka

RIKEN Nishina Center, Wako, Japan

# Vacuum leakage from FPC windows

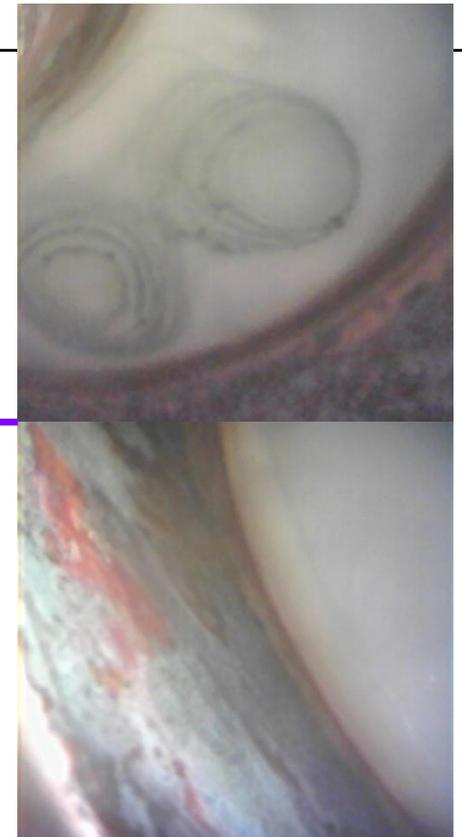
## Most probable process to vacuum leakage:

Dew condensation on air-side of vacuum window

Galvanic corrosion of metallization of alumina

Degradation of brazing of vacuum window

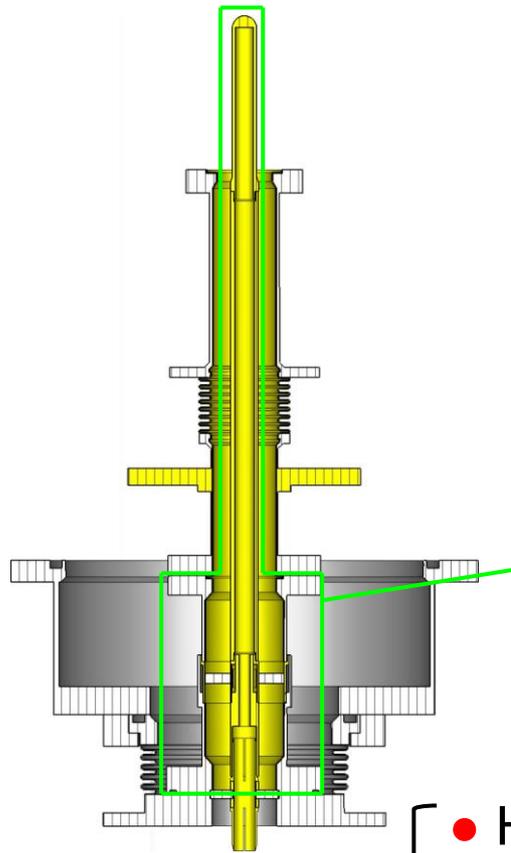
## Components to be replaced:

- Inner conductor
- Vacuum window
- Lower part of outer conductor

- Higher thermal conduction at lower part of outer conductor.

Material of outer conductor below Vac. Win.	Estimated Temp. at vacuum window (Assumed Temp. of lower end of IC and OC are both 300 K)
Present FPCs	SS + Cu-plating	~283 K
New FPCs	<b>Thick copper</b>	~298 K

- Installation of heater around vacuum window.

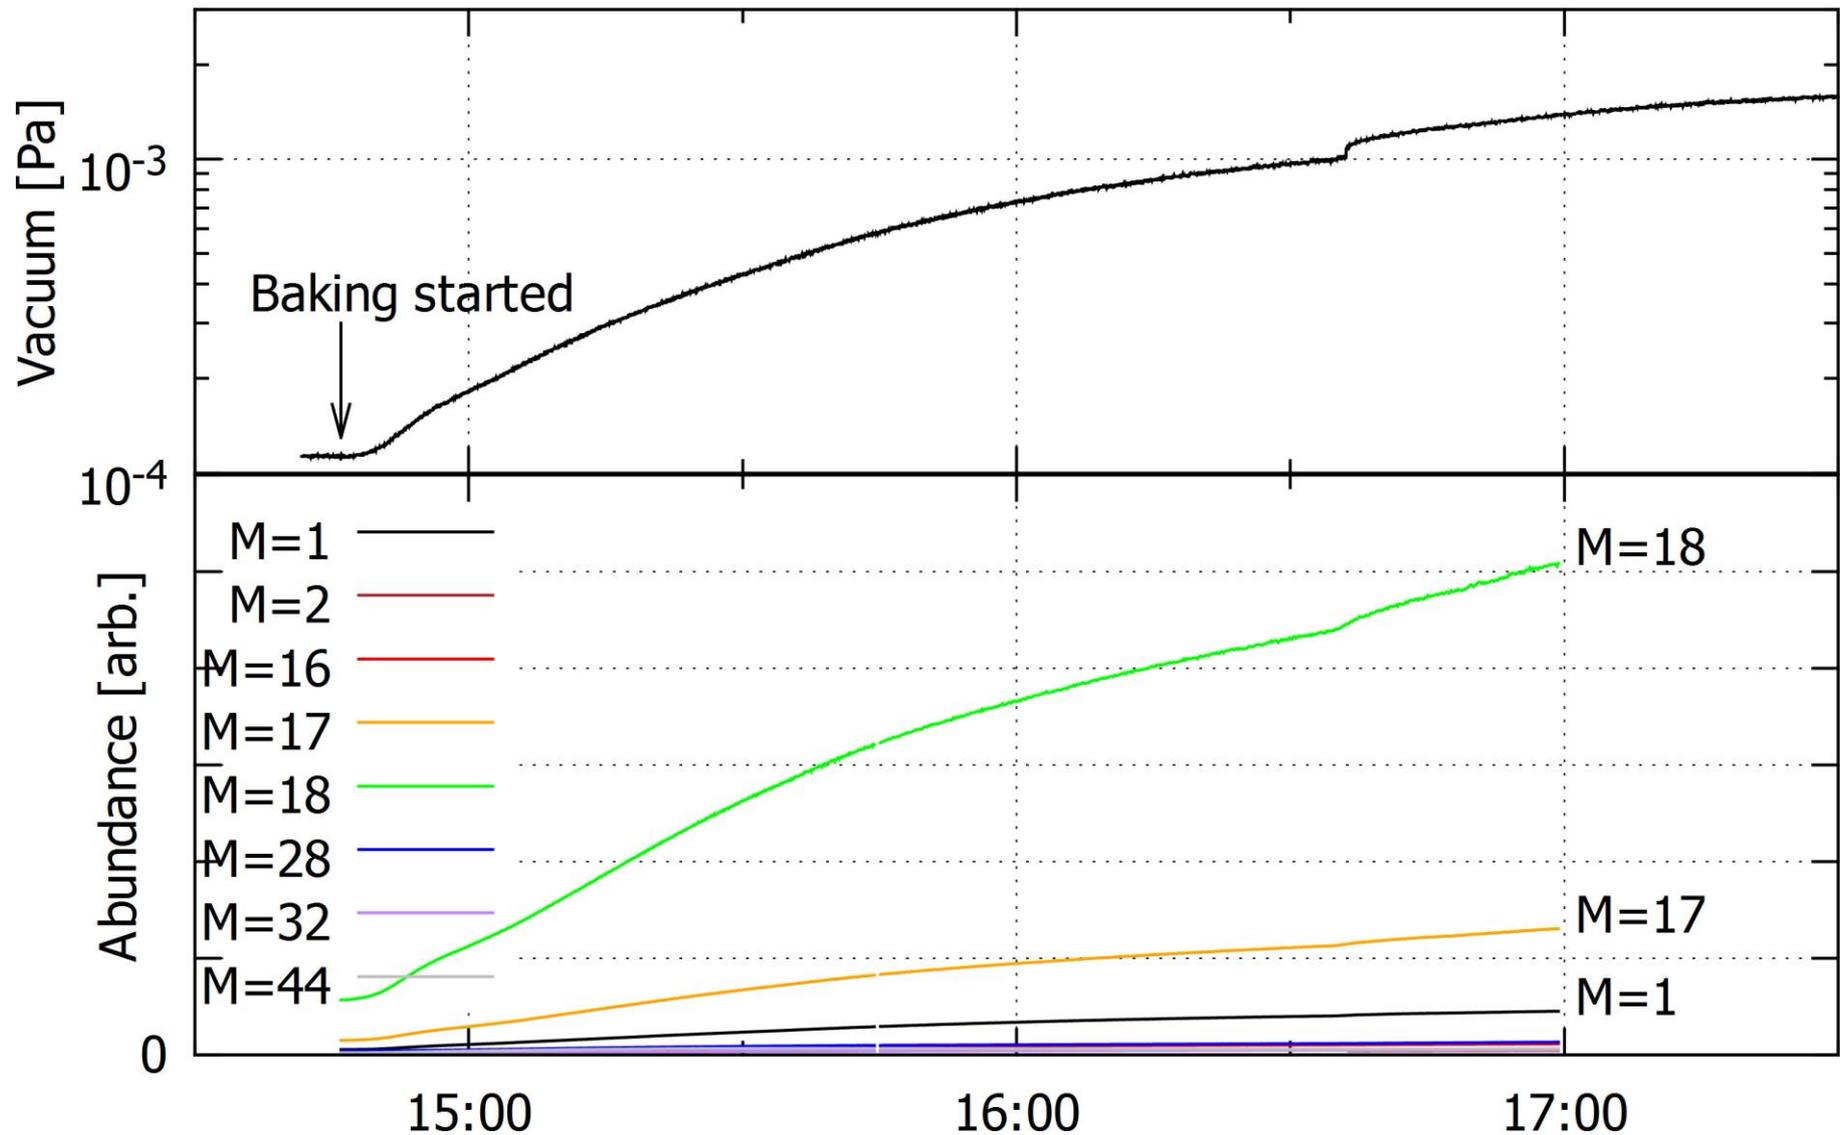
Outgas induced by baking

- $M = 1, 17, 18$  increased by baking.

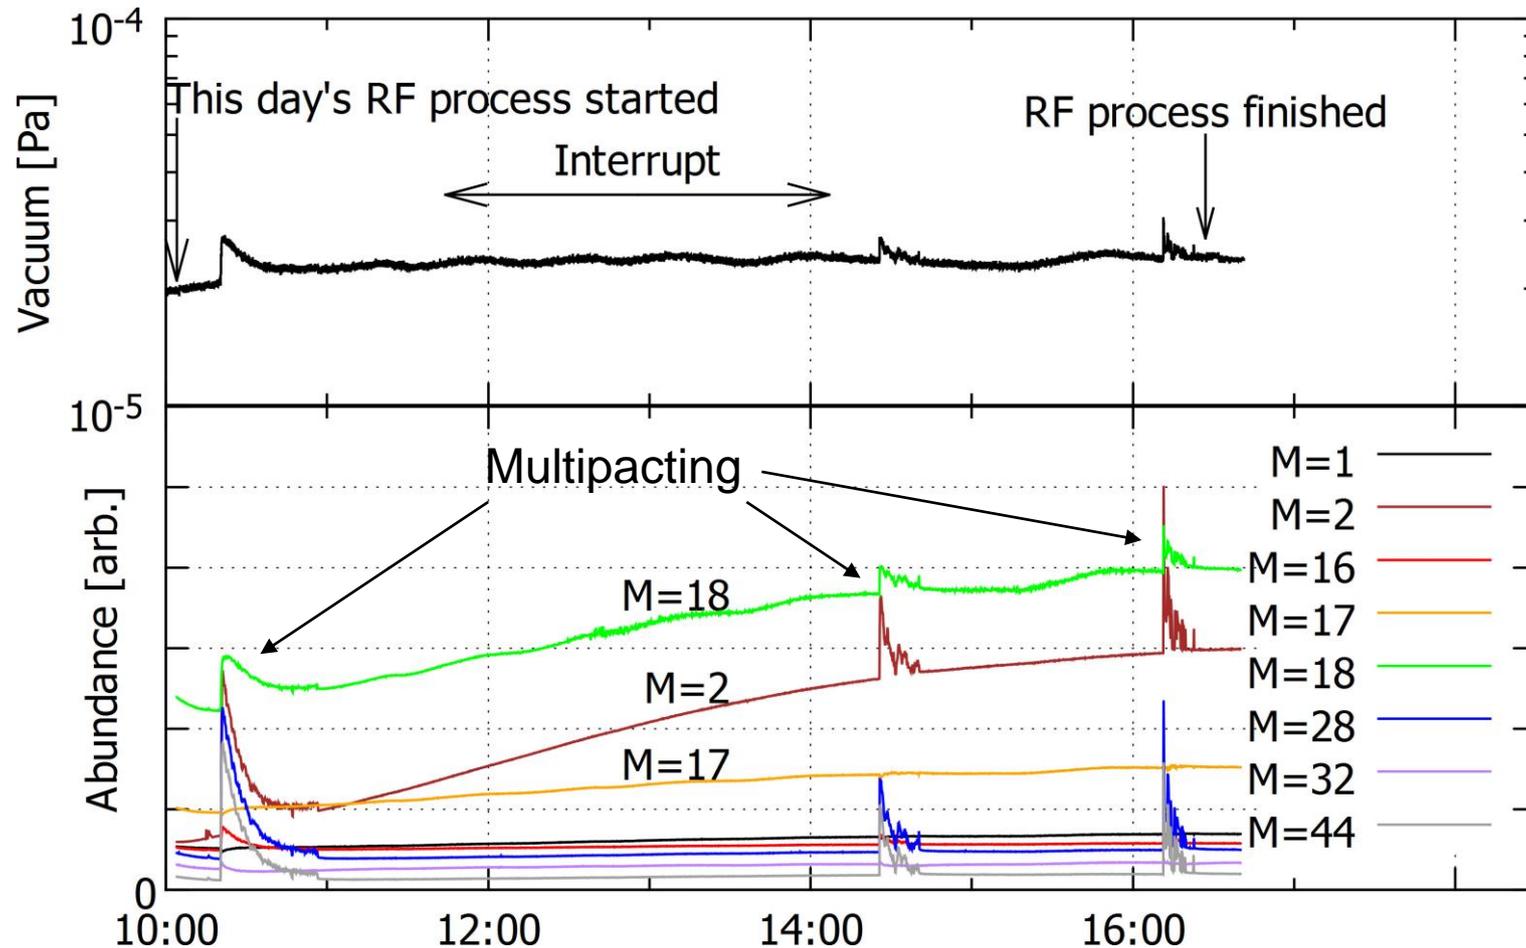
Outgas induced by RF process

- $M = 2, 17, 18$  gradually increased by RF supply.  
(continued to increase even if RF wasn't supplied.)
- $M = 2, 18, 28, 44$  largely increased by multipacting.

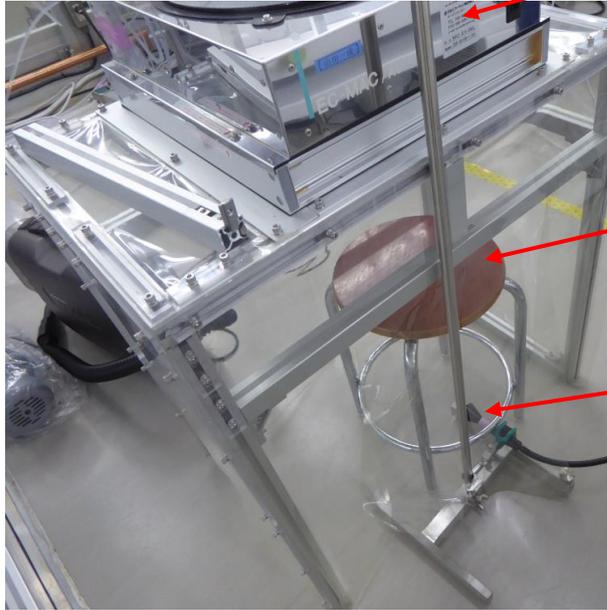
Simple  
clean booth

Clean booth (Plastic curtains)	Number of $\geq 0.1 \mu\text{m}$ particles measured [counts/s]
Closed	ND
Open	< 10 (ISO class ~ 3 ?)

A system to enclose additional fan filter unit and FPC may be needed.

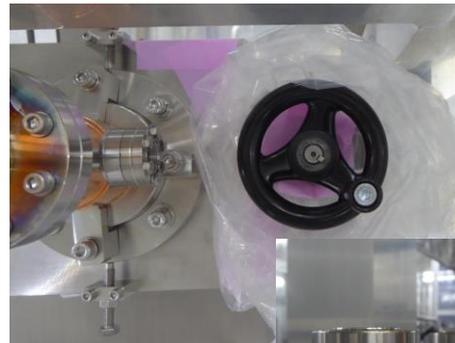
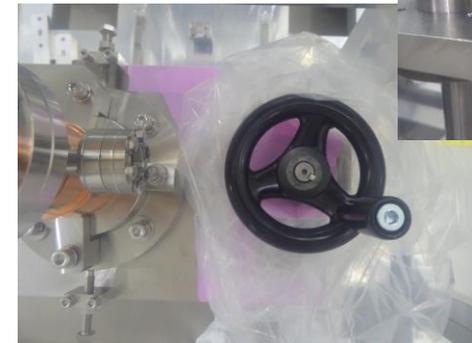
FPC table (with new FPC on it) was raised to the top of shaft.

No rotation
