LIPAc cryomodule assembly progress and lessons learnt

TTC 2022 Aomori
Aomori – 12th October 2022

IFMIF/EVEDA Project

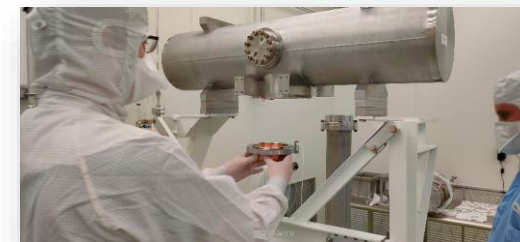
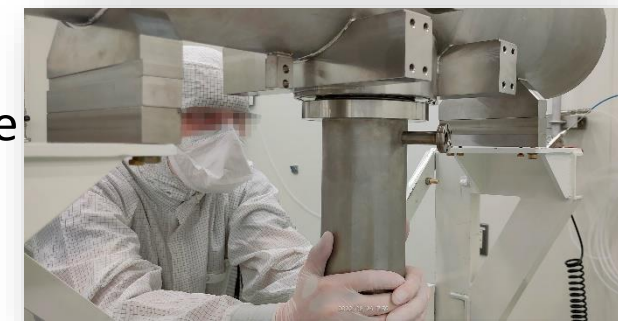
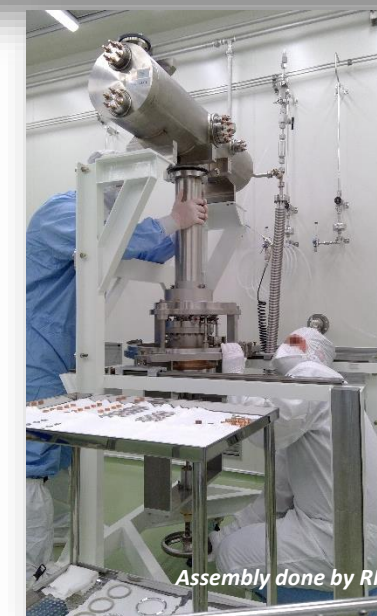
- First attempt was leaking
- Aluminium filings were found on the sealing surface of the cavity from previous gasket
- Careful cleaning of both sealing surfaces (cavity & coupler)
- 2nd leak test looked good but helium background was too high (1.2E-9 mbar.l/s)
- Pumping over a WE did not help, neither bake out of the pumping line
- The calibrated leak of the Slow Pumping System was actually leaking
- Fixed by removing it (leak detector is equipped with its own calibration leak)
- **HWR5/FPC6 assembly is leak tight (3.3E-11 mbar.l/s)**

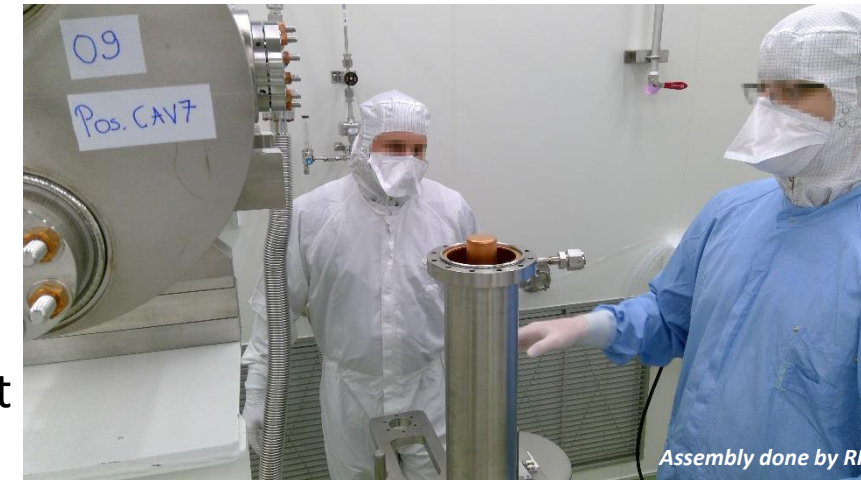
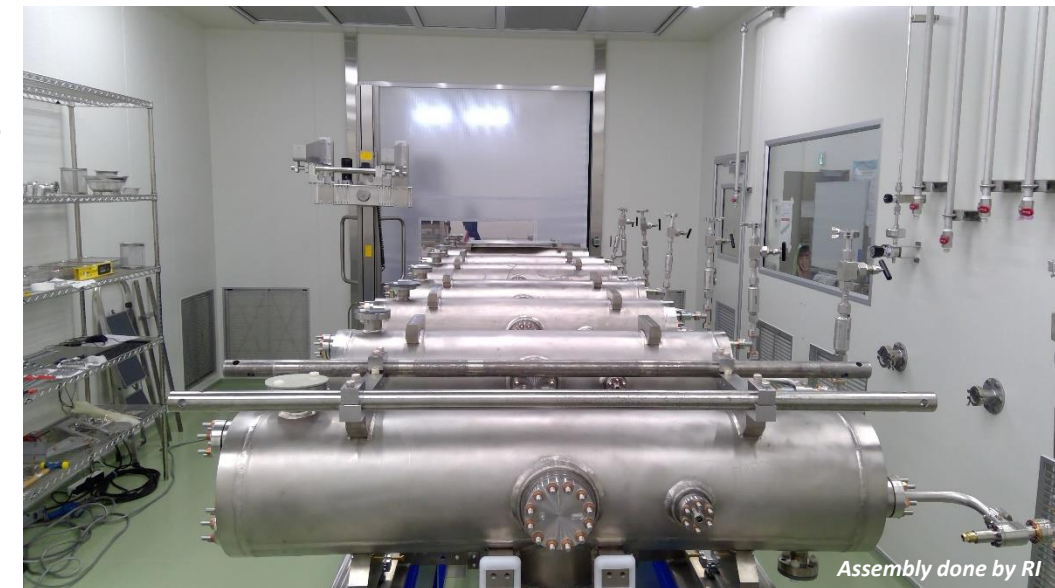
- Systematic cleaning and inspection of the cavity seal groove
- Nearly all assemblies went smoothly then
- The two last assemblies suffered from small leaks at first attempt ($\sim 4E-10$ mbar.l/s)
 - Both gaskets used at first attempt were very good
 - No filings were found when cleaning
 - Leak were solved by replacing the gasket
 - **Speculated:** small Al filing trapped in the interface and removed by the first Helicoflex gasket
- Assembly of all cavities with their power coupler is now completed

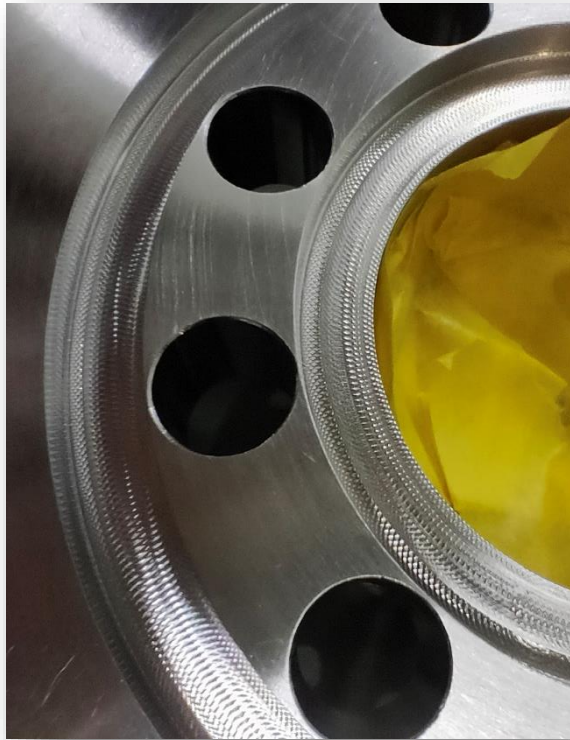
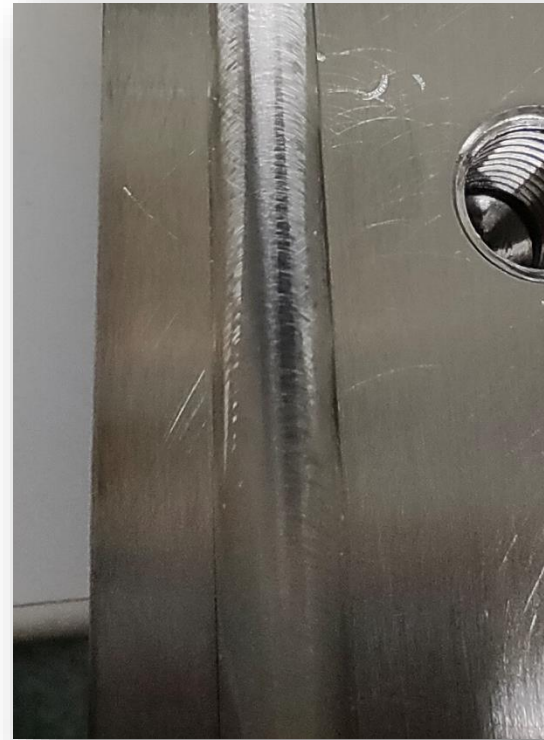
- **Non conformity on HN and EPDM sealing surfaces**
 - The first cold warm assembly was leaking at inspection
 - The two cold warm transitions had no rework of their sealing surfaces after machining

Incorrect sealing surfaces with machining traces

- Seven solenoids have been leak tested prior to assembly.
- One solenoid is waiting for its last BPM button.
- Rework of the CWT sealing surfaces still on going.

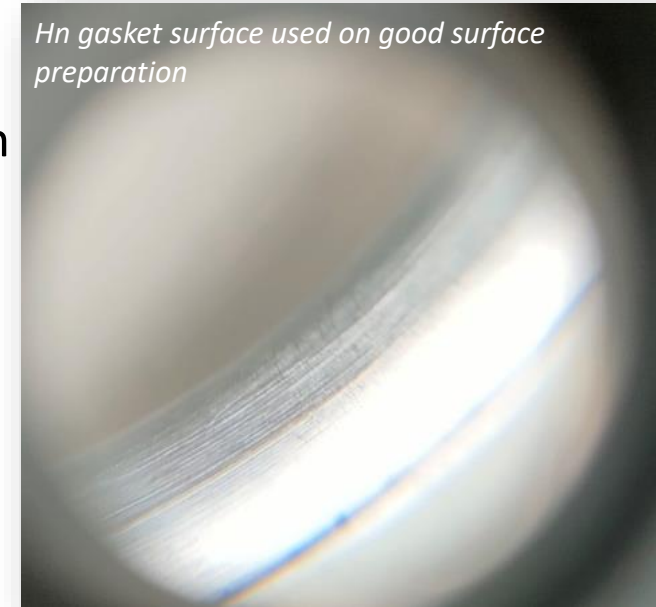
Hn gasket surface used on good surface preparation

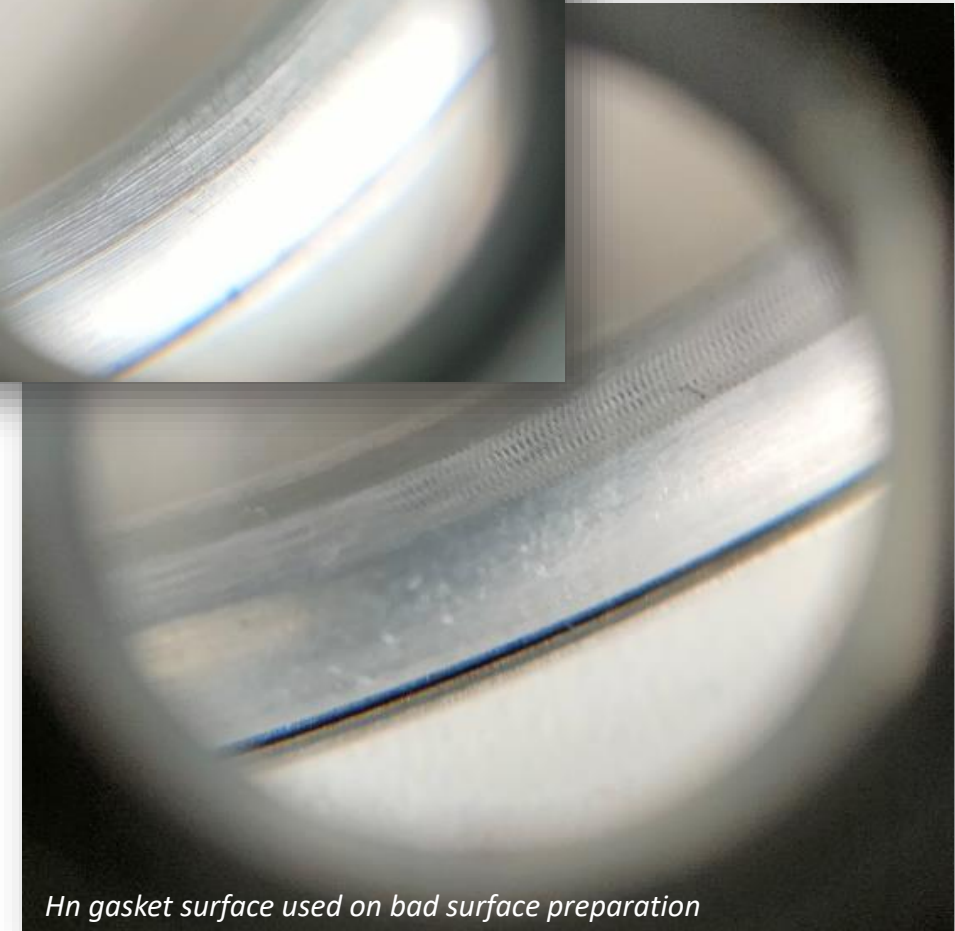
Hn gasket surface used on bad surface preparation

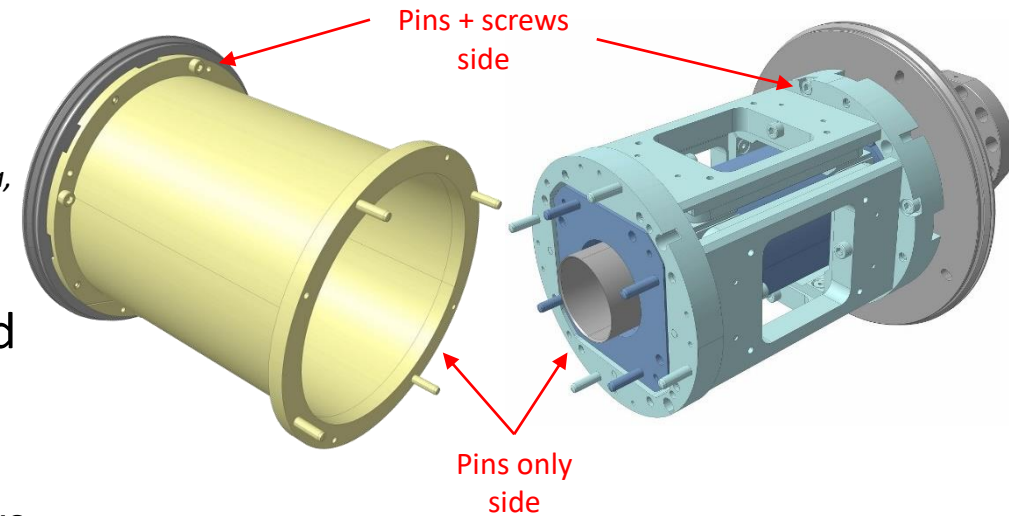
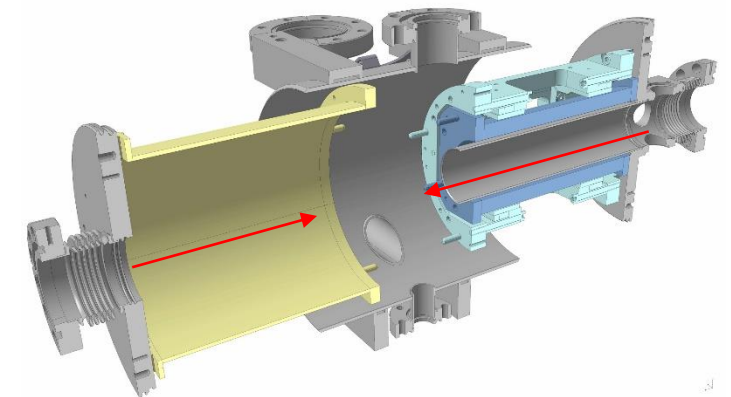
- **A rattling noise was detected during the HPR process of the solenoids → a screw was found in the Helium tank**
(see Troubleshooting during high pressure rinsing of superconducting solenoid packages for LIPAc, T. Ebisawa, TTC 2022)
- During the assembly each coil was centred with 4 pins and locked with 4 screws to one of the helium vessel flange.
 - The coils are covered by Epoxy (risk of damage is low)
 - The current is ramped, limiting the movement of the screws if any (due to magnetisation)
- It was decided to make a CT scan of all solenoids to inspect all screws and pins status
 - Fast technique
 - Can be done with the solenoids in double bags

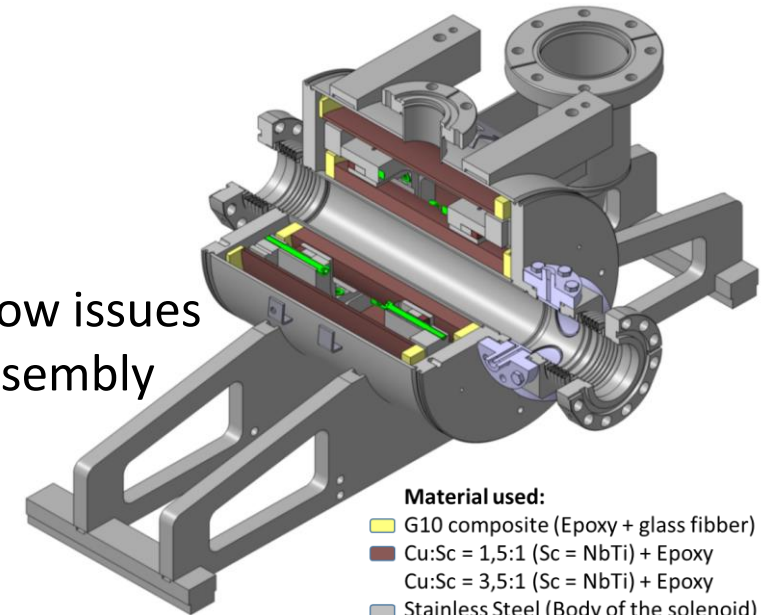
- In July all solenoids were send to Hitachi for the CT scan
- Many solenoids have retracted pins (partially and fully)
- Two Solenoids could possibly have some strong issues, a third one possibly low issues
 - 1 - Retracted/missing pins + 1 cable strand possibly damaged at the assembly
 - 2 - Retracted/missing pins
 - 3 - 2 missing pins for the inner solenoid
- Only the sides without screws are affected by the retracted/missing pins
- This should limit the impact on the alignment of the coils
- Any move of the coils will quench the magnet when ramping the current

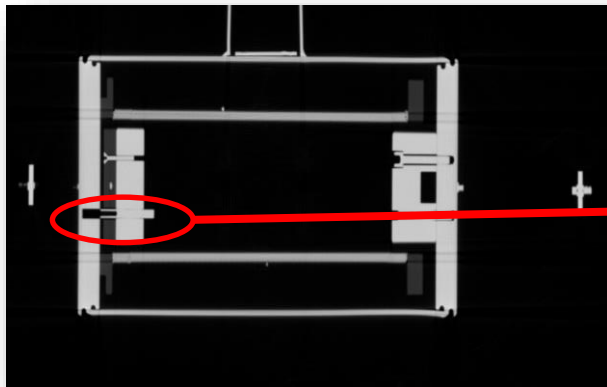
Example of a retracted pin

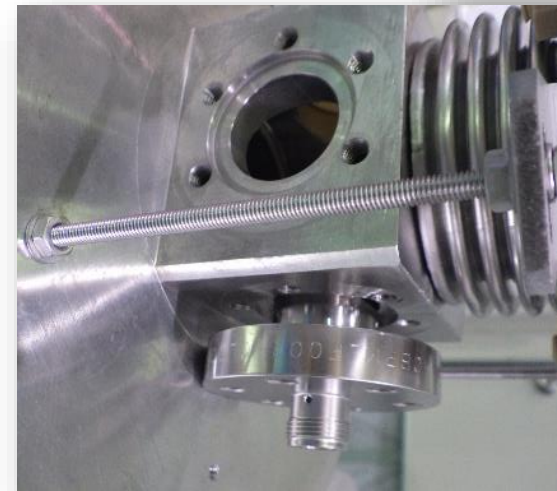
- BPM buttons were assembled in cleanroom after HPR by MHI
- On one solenoid, assembly of one button was impossible
 - This solenoid was previously repaired due to a thread leaking in beam line
 - Thread was recharged by welding prior to a new tapping
 - Possibly, heat may have deformed the BPM cavity (tolerances are very thin)
 - Button was polished by 0.05 mm and assembled but a small gap remains. New polishing on going

Before polishing

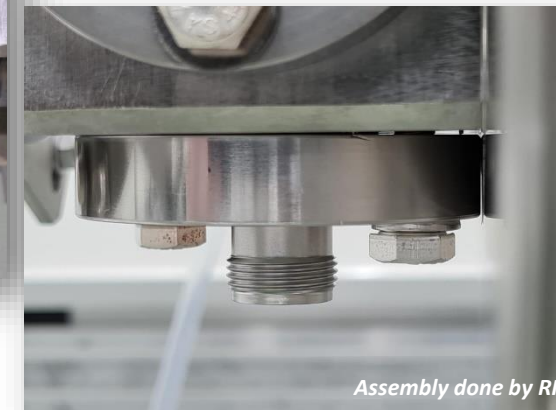
After polishing
