# Large Grain Cavity R&D

TTC 2022

# 3-cell LG Cavity R&D

# 9-cell LG Cavity: KEK7

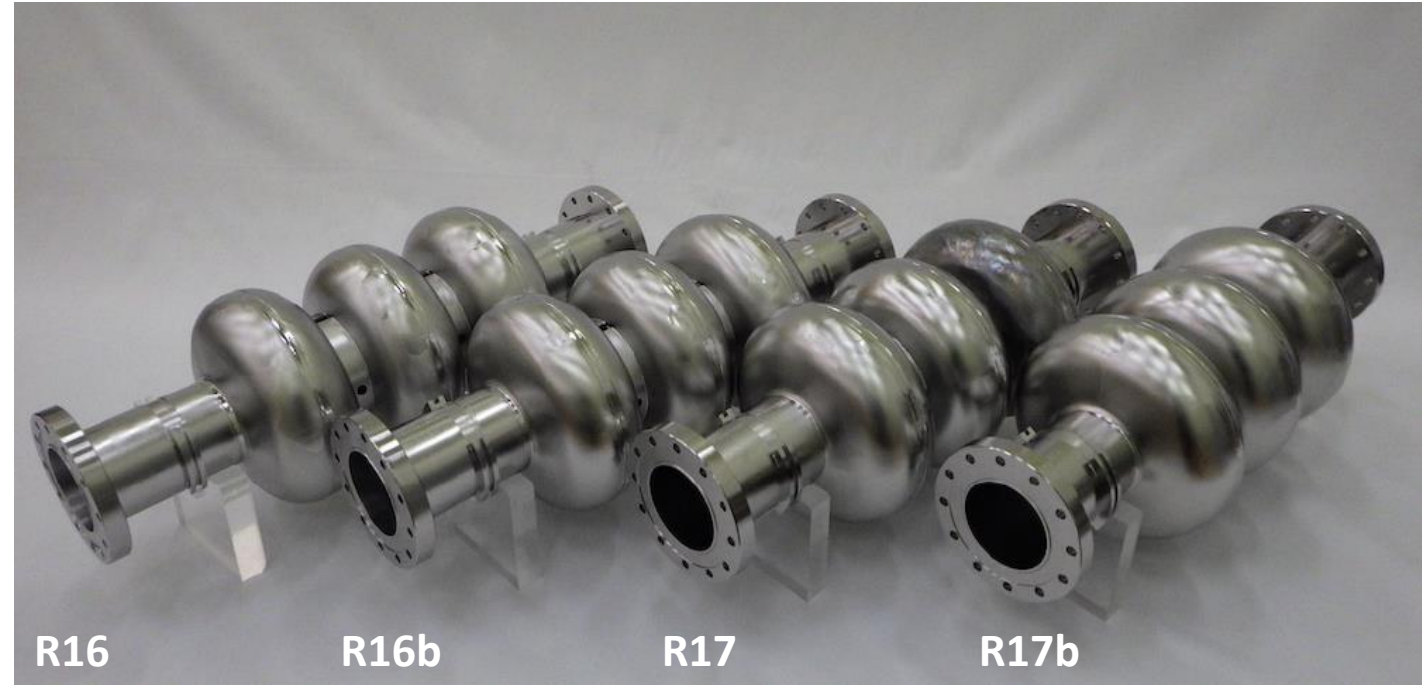
- Motivation
  - ILC cost reduction R&D
- Properties
  - TESLA-shape 3-cell cavity
  - High-RRR
  - Large-Grain Nb
  - Manufactured at KEK CFF

RRR	Ta (ppm)	Cavity
ILC TDR	$\geq 300$	$\leq 500$	-
High RRR, Low Ta	500	20	R16, R16b
High RRR, High Ta	363	1390	R17, R17b

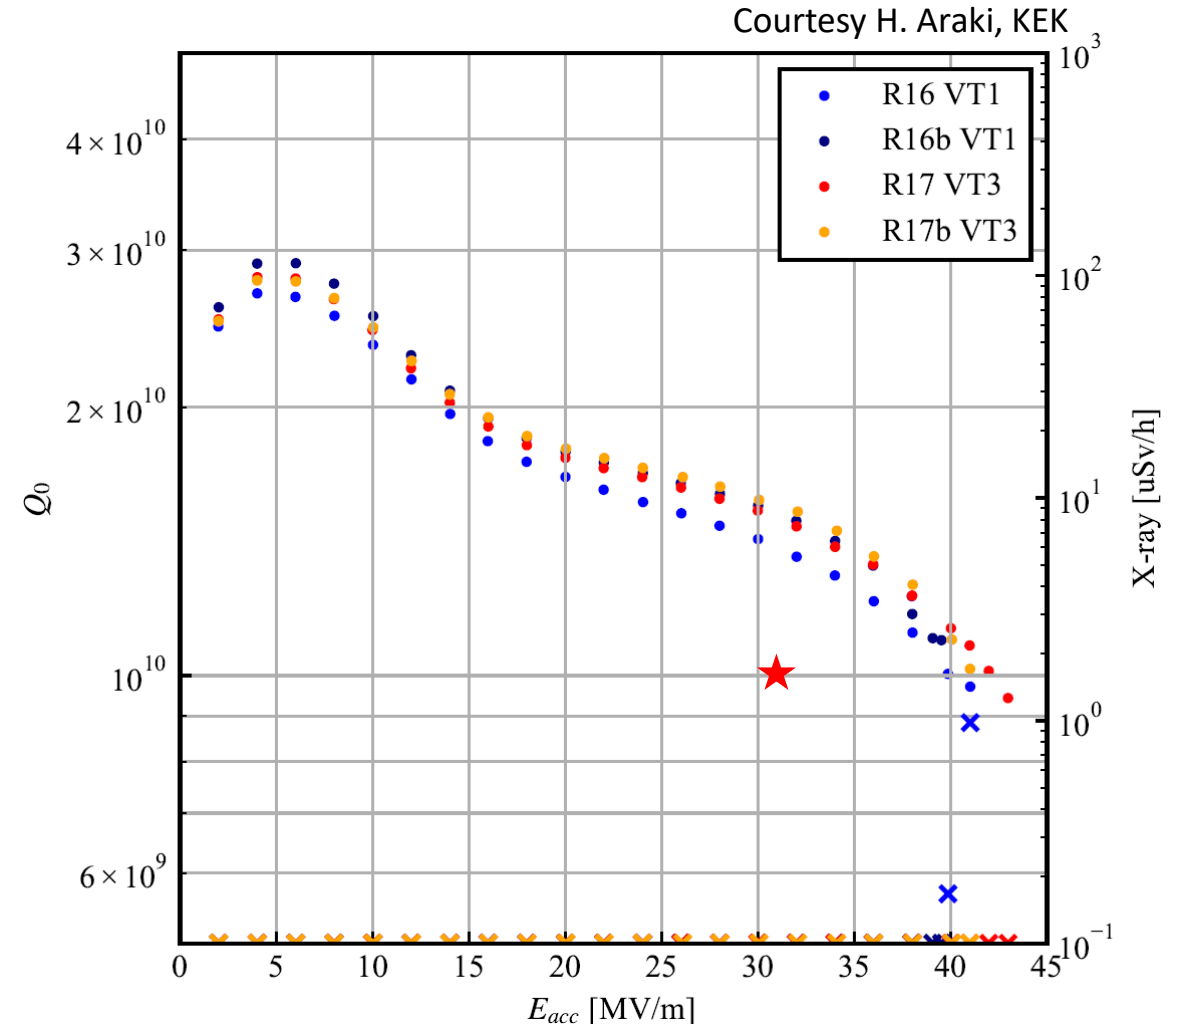
# 3-cell LG Cavity VT Test Results

- All cavities were treated according to the ILC TDR
  - Pre-EP (5  $\mu\text{m}$ ) & EP-1 (100  $\mu\text{m}$ )
  - Annealing (800°C 3h)
  - Local grinding
  - EP-2 (20  $\mu\text{m}$ )
  - Baking (120°C 48h)
  - R17 and R17b received additional local grinding and EP-2
- All achieved ILC TDR specifications (★)

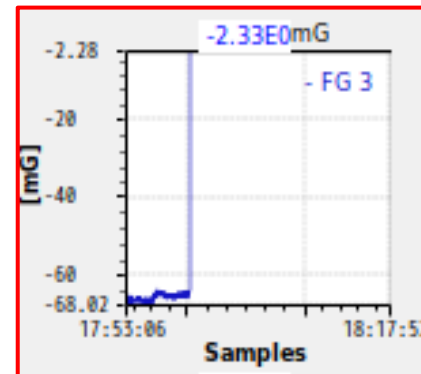
- R17 VT3 showed the largest degradation

- 43.1 MV/m to 30.0 MV/m
- A change of over **60 mG** on the outer surface

- We believe the environmental magnetic field is locally trapped at the quenching site

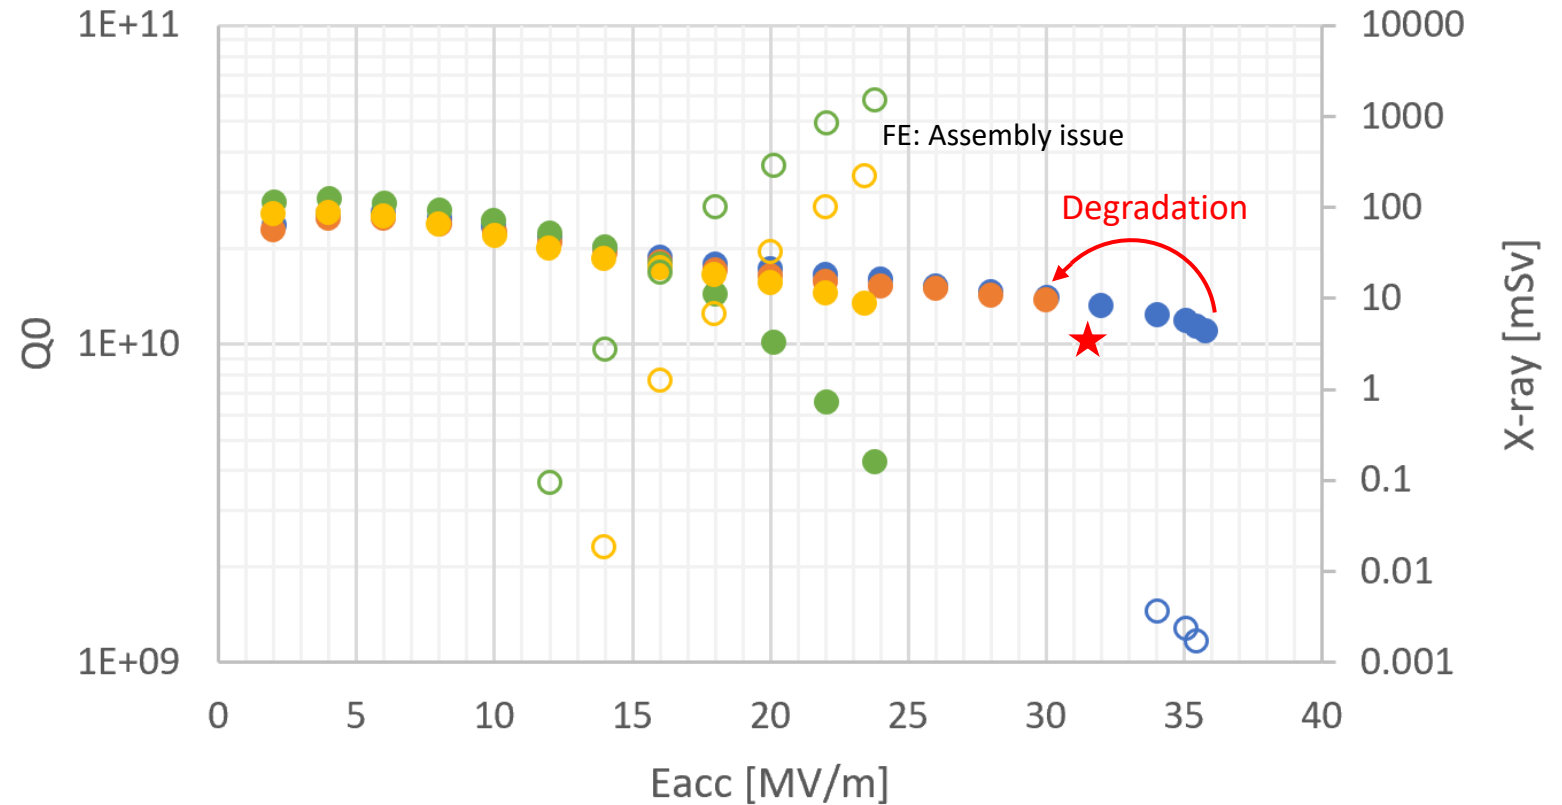
# Comparison Q0 vs Eacc of KEK7 VT1, VT2, and VT3

- VT1 initial  $\pi$  mode fulfilled ILC TDR specifications (★)
- Degradation during  $6\pi/9$ -mode measurement in VT1 by 5.8 MV/m
- FT in VT2 and VT3 is an assembly issue

● VT1 Initial  $\pi$  Q0    ● VT1 Final  $\pi$  Q0    ● VT2 Final  $\pi$  Q0    ● VT3 Final  $\pi$  Q0  
○ VT1 Initial  $\pi$  X-ray    ○ VT1 Final  $\pi$  X-ray    ○ VT2 Final  $\pi$  X-ray    ○ VT3 Final  $\pi$  X-ray

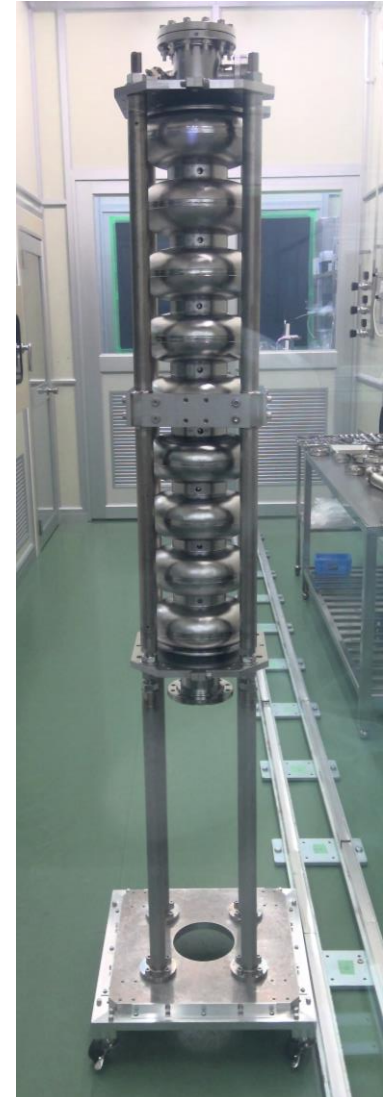
- Cavity was closed at within the HPR stand
- It was moved to the C1000CR and dry and clean blown
- It was moved to the C10CR
- Even after removing all four bolts, the bottom beam-pipe blind flange stayed put
- In order to remove the bottom beam-pipe blind flange, a little force was required
- A sucking sound occurred
- There must have been negative pressure inside the cavity
- First time observed for 9-cell cavity

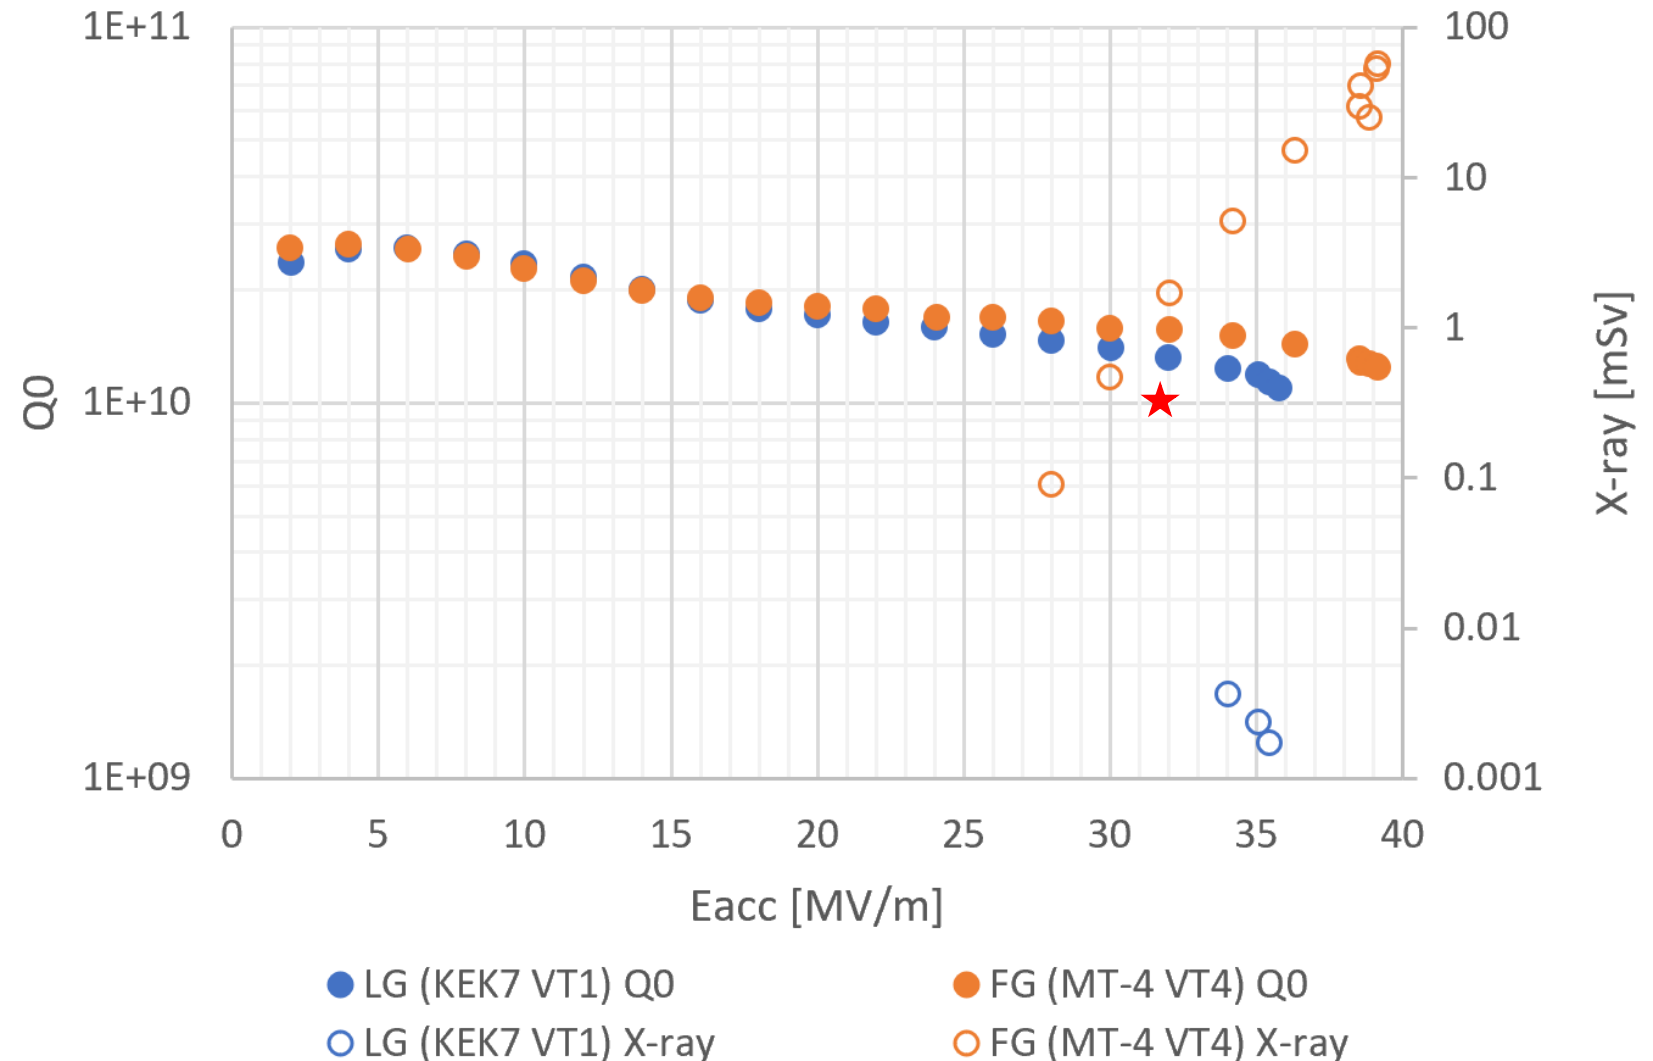
# Comparison of Q0 vs Eacc for LG and FG

- Both cavities received standard treatment
  - Baking (120°C 48h)
- Both fulfilled ILC TDR specifications (★)
- Remark: Magnetic field is not controllable for 9-cell cavities

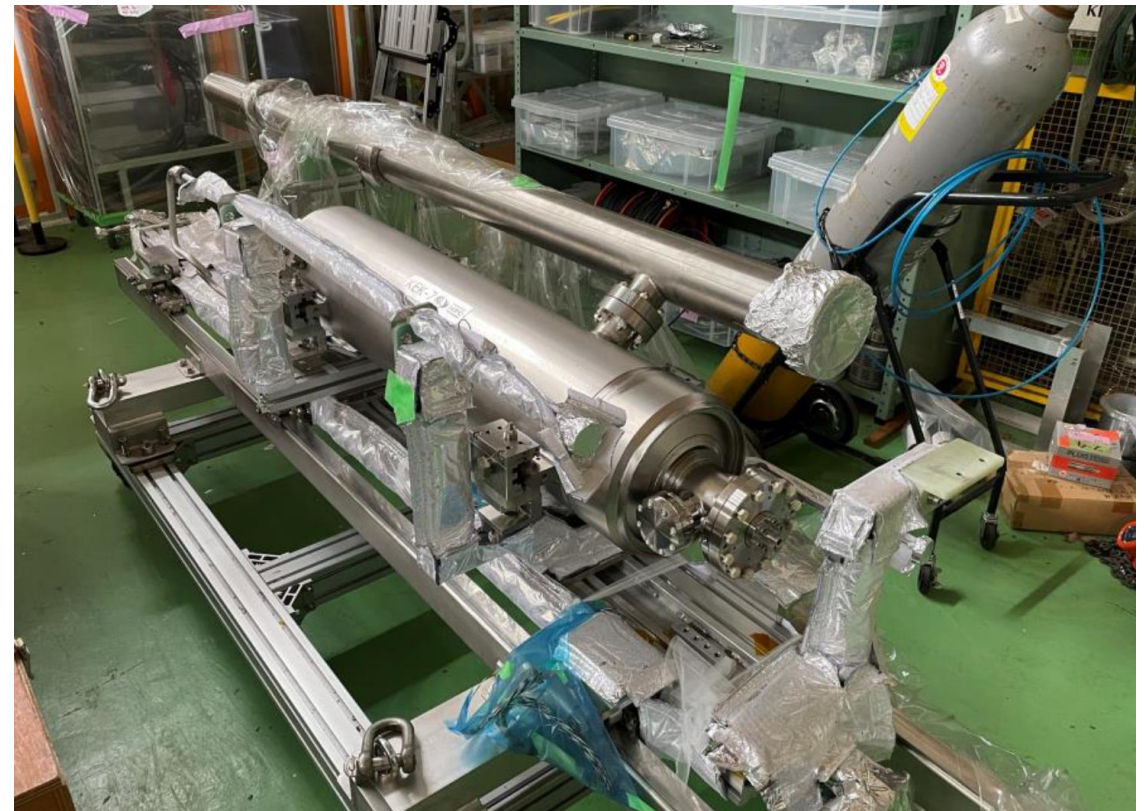
- We believe FE can be overcome by additional HPR and performance as in initial  $\pi$ -mode measurement of VT1 can be achieved
- Proceed with preparation for horizontal test
  - KEK7 was jacketed
  - Leak check passed
  - Pressure test passed
  - Production of magnetic shield
- Plan for 1<sup>st</sup> HT in January 2023
