# Present status of RIKEN power coupler

OZEKI, Kazutaka

RIKEN Nishina Center, Wako, Japan

# Vacuum leakage from FPC windows

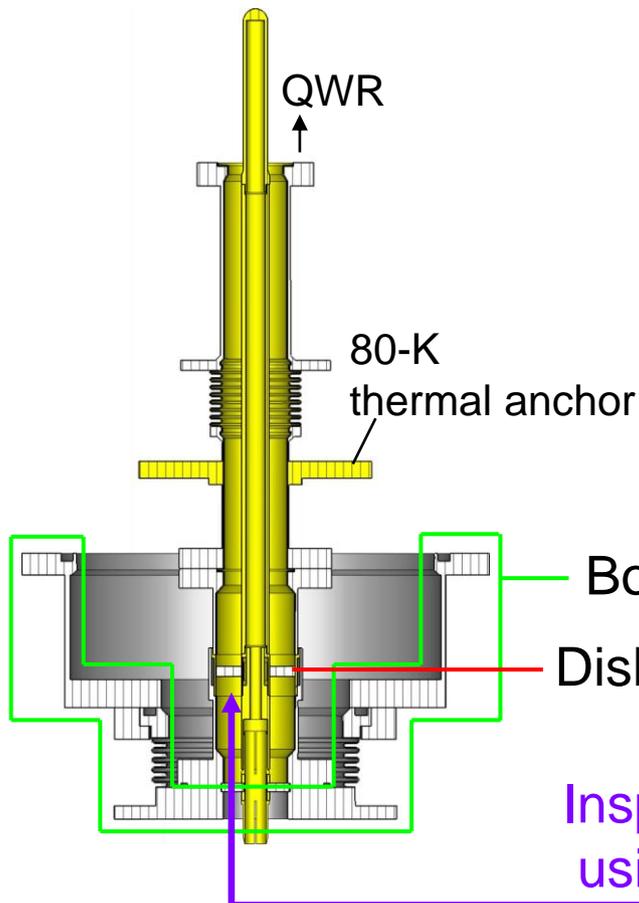
2019	Mar. Sep.~	Assembly and installation of CMs. Evacuation of QWRs and CMs, cool-down test of CMs. <b>Nov. 17: Vacuum leakage from a FPC window.</b>
2020	Jan. Jun.~	1 <sup>st</sup> beam acceleration test. Beam delivery to experiments. <b>Oct. 27: Vacuum leakage from another FPC window.</b>
	Dec.	Redesign and production of new FPCs.
2021	May Aug. Sep.	Installation of outer windows to SC05 and SC06. Delivery of four new FPCs. Installation of outer windows to remaining eight FPCs.
2022	Nov.	Six new FPCs will be delivered.

## Most probable process to vacuum leakage:

Dew condensation on air-side of vacuum window

Galvanic corrosion of metallization of alumina

Degradation of brazing of vacuum window

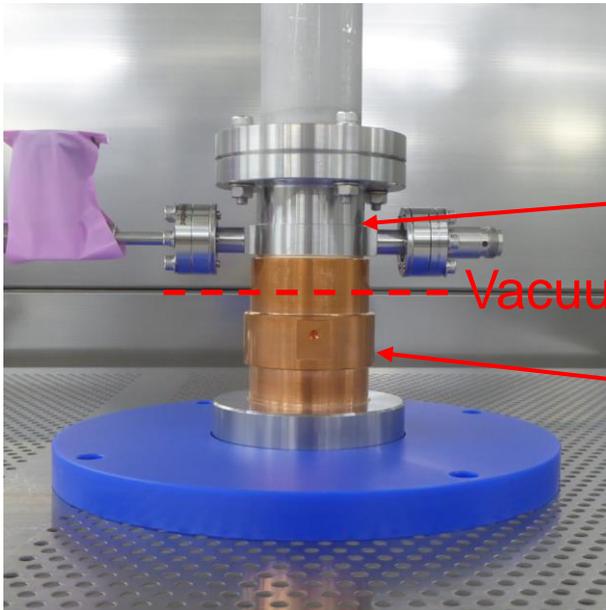
Outer conductor: SS + Cu-plating

Vacuum window

Outer conductor: Thick copper

## Pre-processing in ISO class-1 clean room:

- Particle removal (blow only)
  - Installation to RF test chamber
  - Evacuation
  - Baking (2 days)
  - RF process (w/ outer window)
  - Sealing w/ dry N<sub>2</sub>
- } Outgas measurement

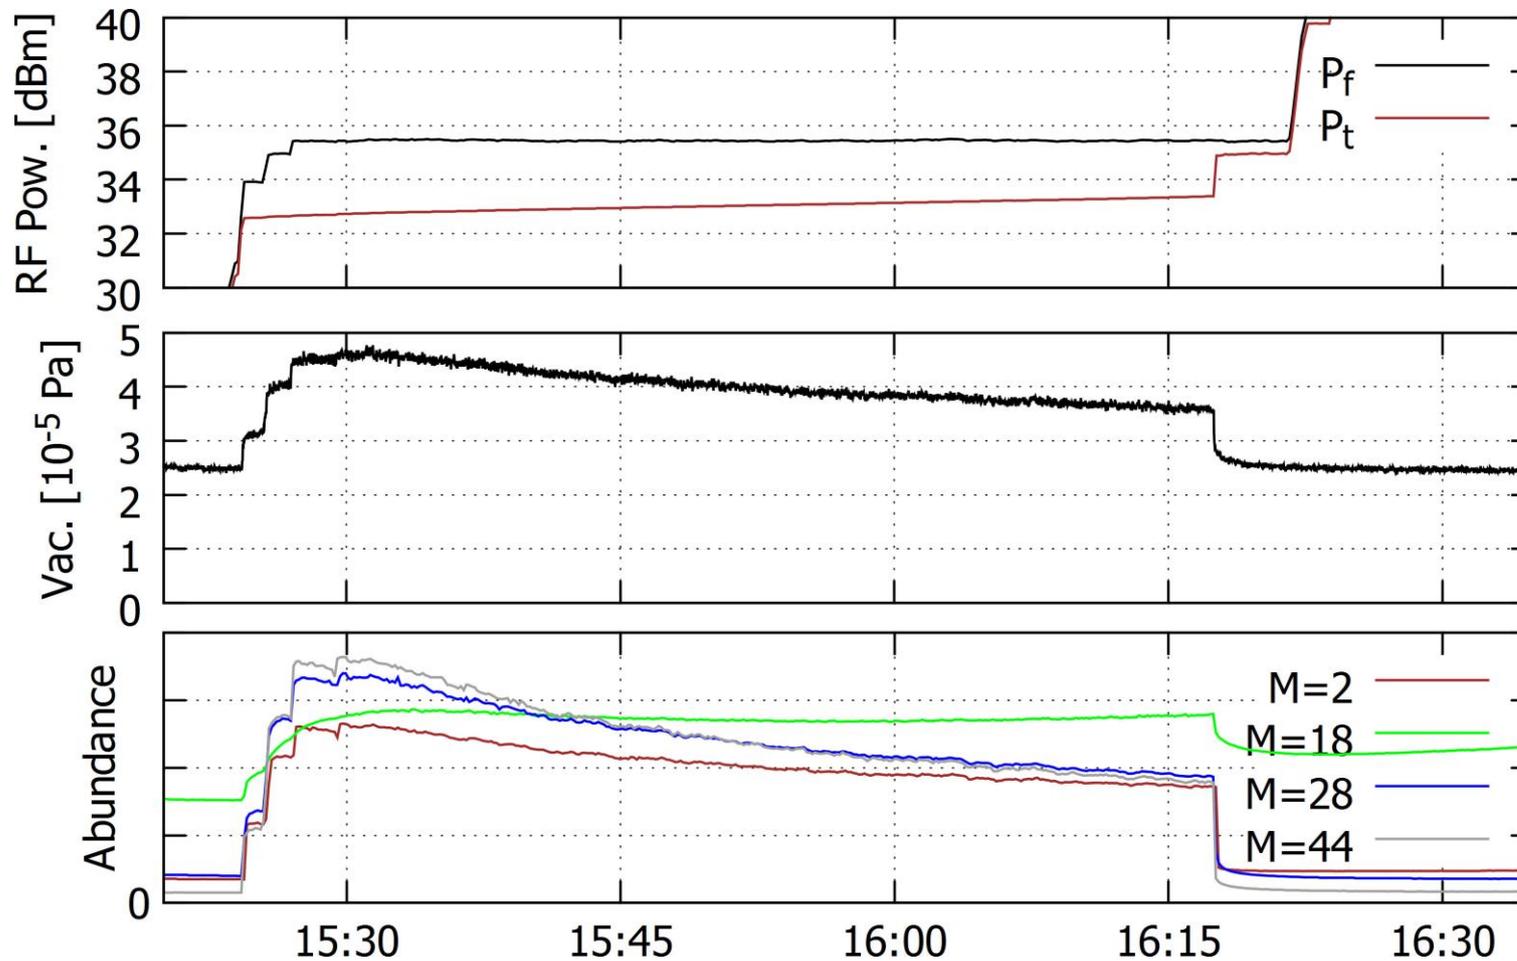
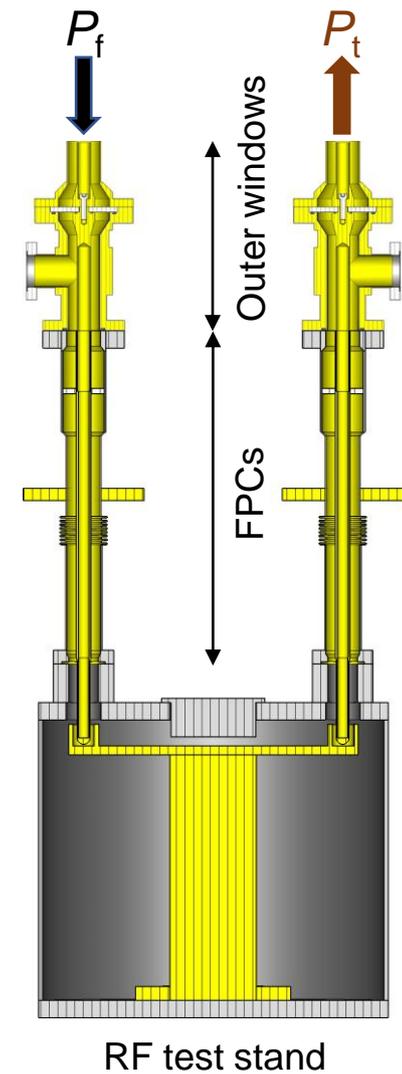
Another example of outgas induced by multipacting

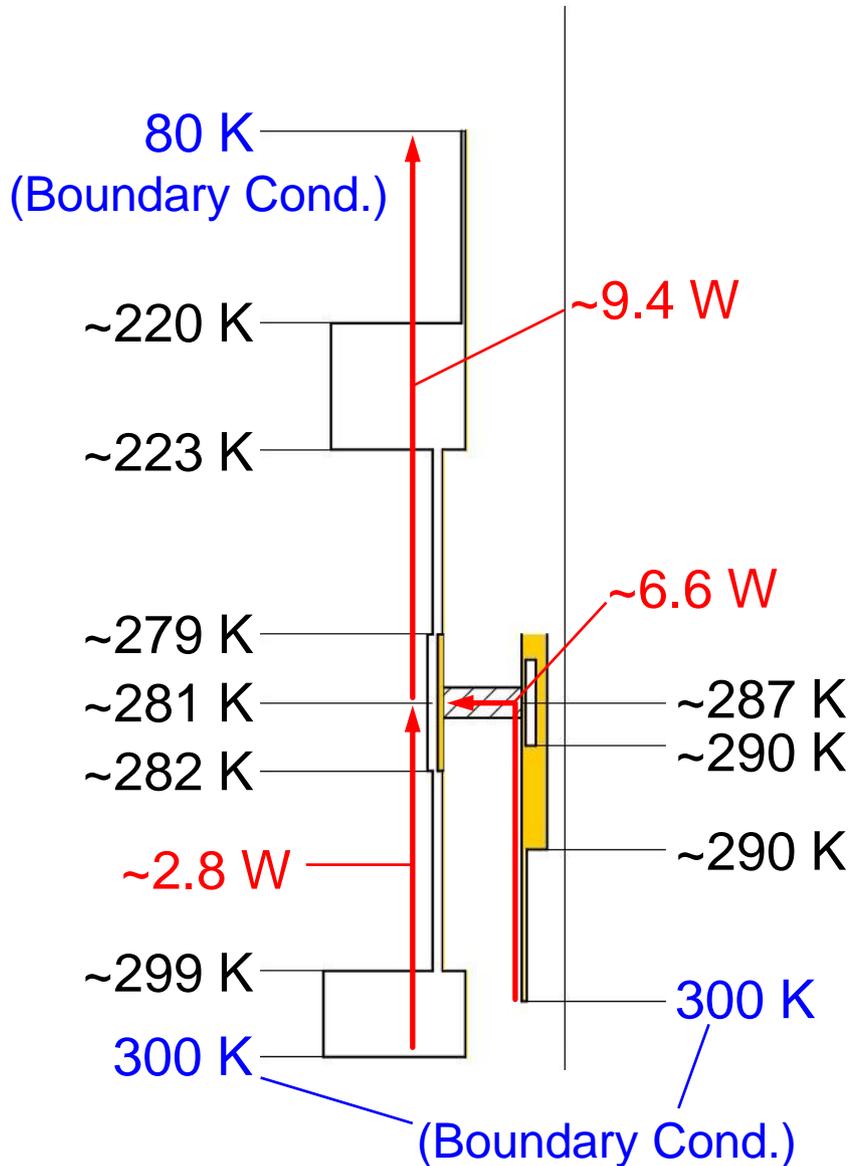
Present FPC

Material of outer conductor below Vac. Win.	Estimated Temp. at vacuum window (Assumed Temp. of lower end of IC and OC are both 300 K)
Present FPCs	SS + Cu-plating	~283 K
New FPCs	<b>Thick copper</b>	~298 K

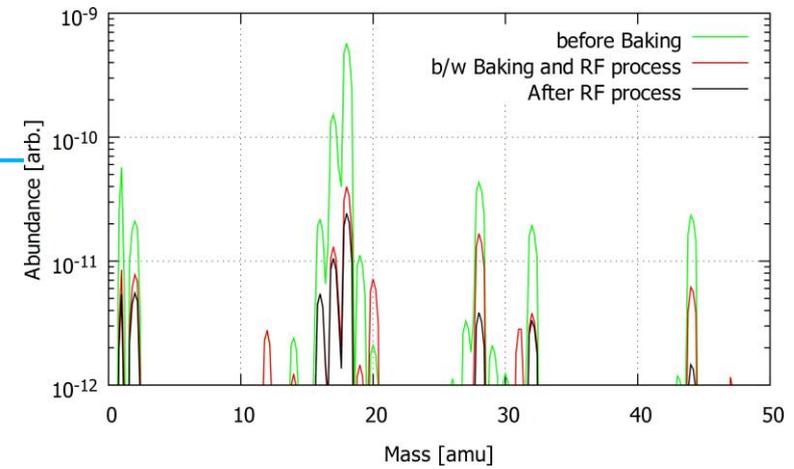
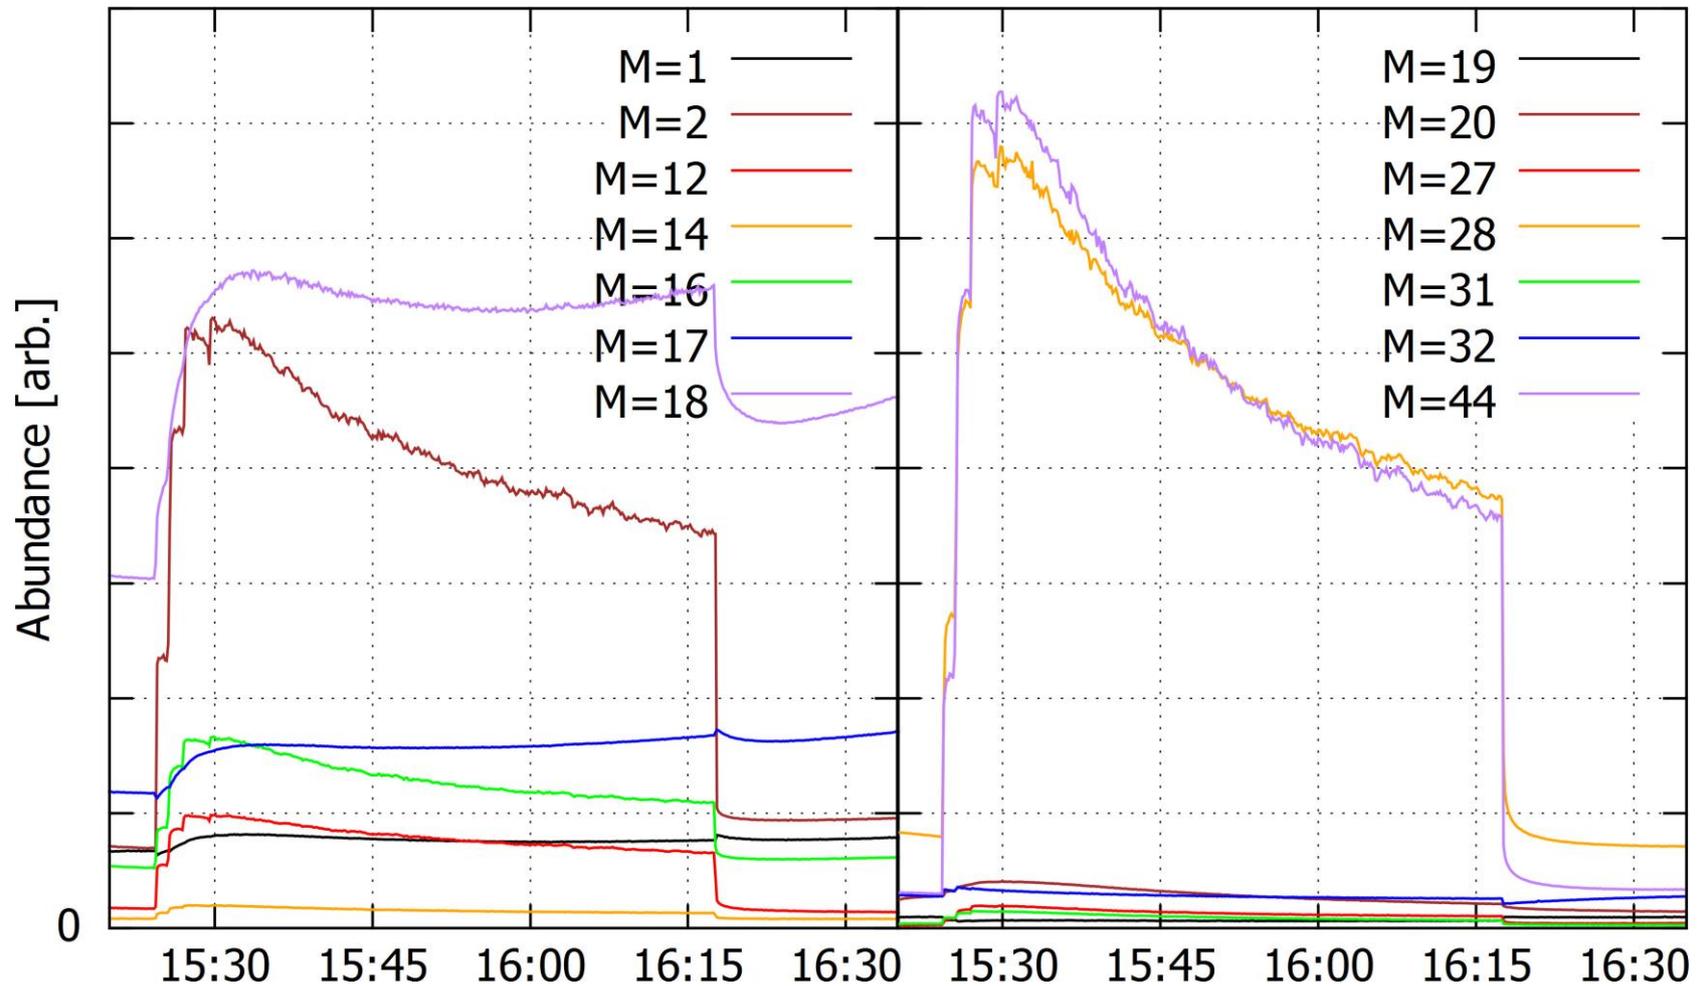
# Outgas induced by multipacting

All detected masses are plotted.
