LIPAc cryomodule assembly progress and lessons learnt

TTC 2022 Aomori
Aomori – 12th October 2022

IFMIF/EVEDA Project

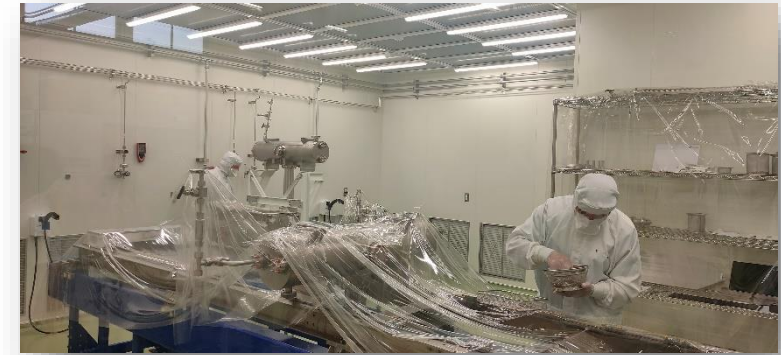
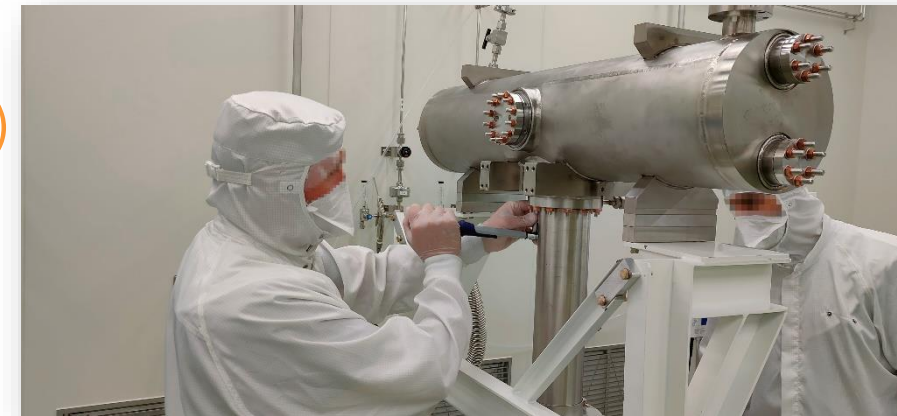
- In June 2022, visit of Research Instrument and F4E to Rokkasho
 - Discussion with QST to prepare the restart of the activities (Stopped for 3.5 years)
 - Checking of the new Slow Pumping System - SPS
 - With all metal gaskets
 - The last Cavity/Coupler was suspected to have a leak
 - Permeation was suspected through O-rings of the previous SPS
 - Issue was suspected also from Aluminium gasket used for RF tests that could possibly damage Helicoflex sealing Surfaces → no damage but filing production (test done at RI)
 - Torque applied was checked
 - New leak test was done
- the last assembly was indeed leak tight**

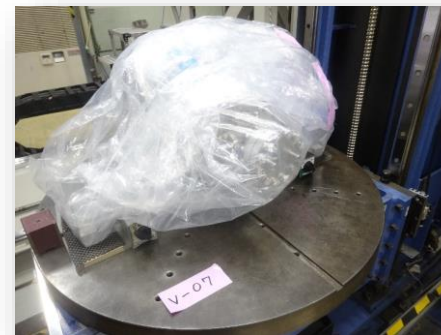
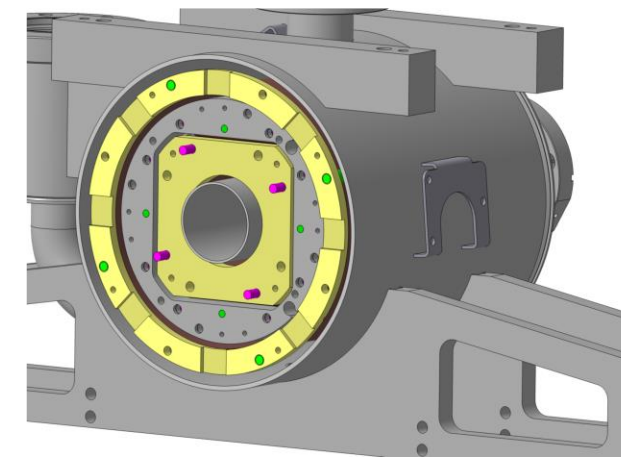
- Special Beam Physics Group (BPG) meetings were dedicated to analyse the consequences of one or more missing solenoid on the beam line

- Different simulations done (QST and CEA)
- First and last solenoid are critical for the operation of the LINAC
- Solenoid 4 and 7 can be turned off (Sol4 for a better beam physics)
- Solenoid 2 will be the third dedicated position for a degraded mode
- Disassembly scenario was assessed to swap with new solenoids

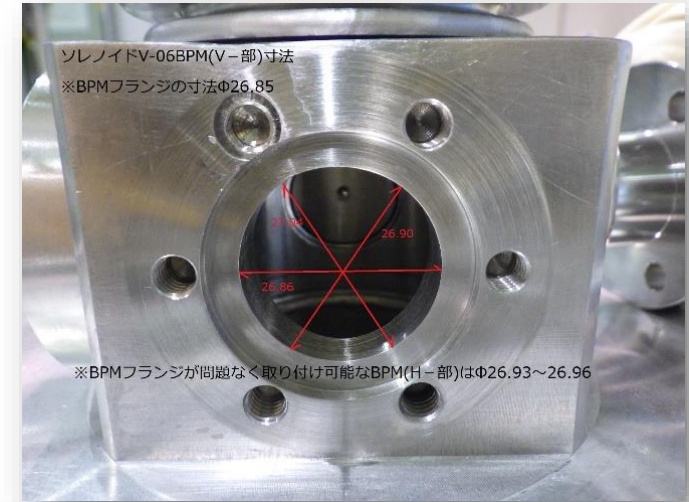
- BPM buttons were assembled in cleanroom after HPR by MHI
- On one solenoid, assembly of one button was impossible
 - This solenoid was previously repaired due to a thread leaking in beam line
 - Thread was recharged by welding prior to a new tapping
 - Possibly, heat may have deformed the BPM cavity (tolerances are very thin)
 - Button was polished by 0.05 mm and assembled but a small gap remains. New polishing on going
